BPM Development at the VUV-FEL

Work during KW40-41 - Oct. 3-16, 2005

TTF meeting, Nov. 3, 2005

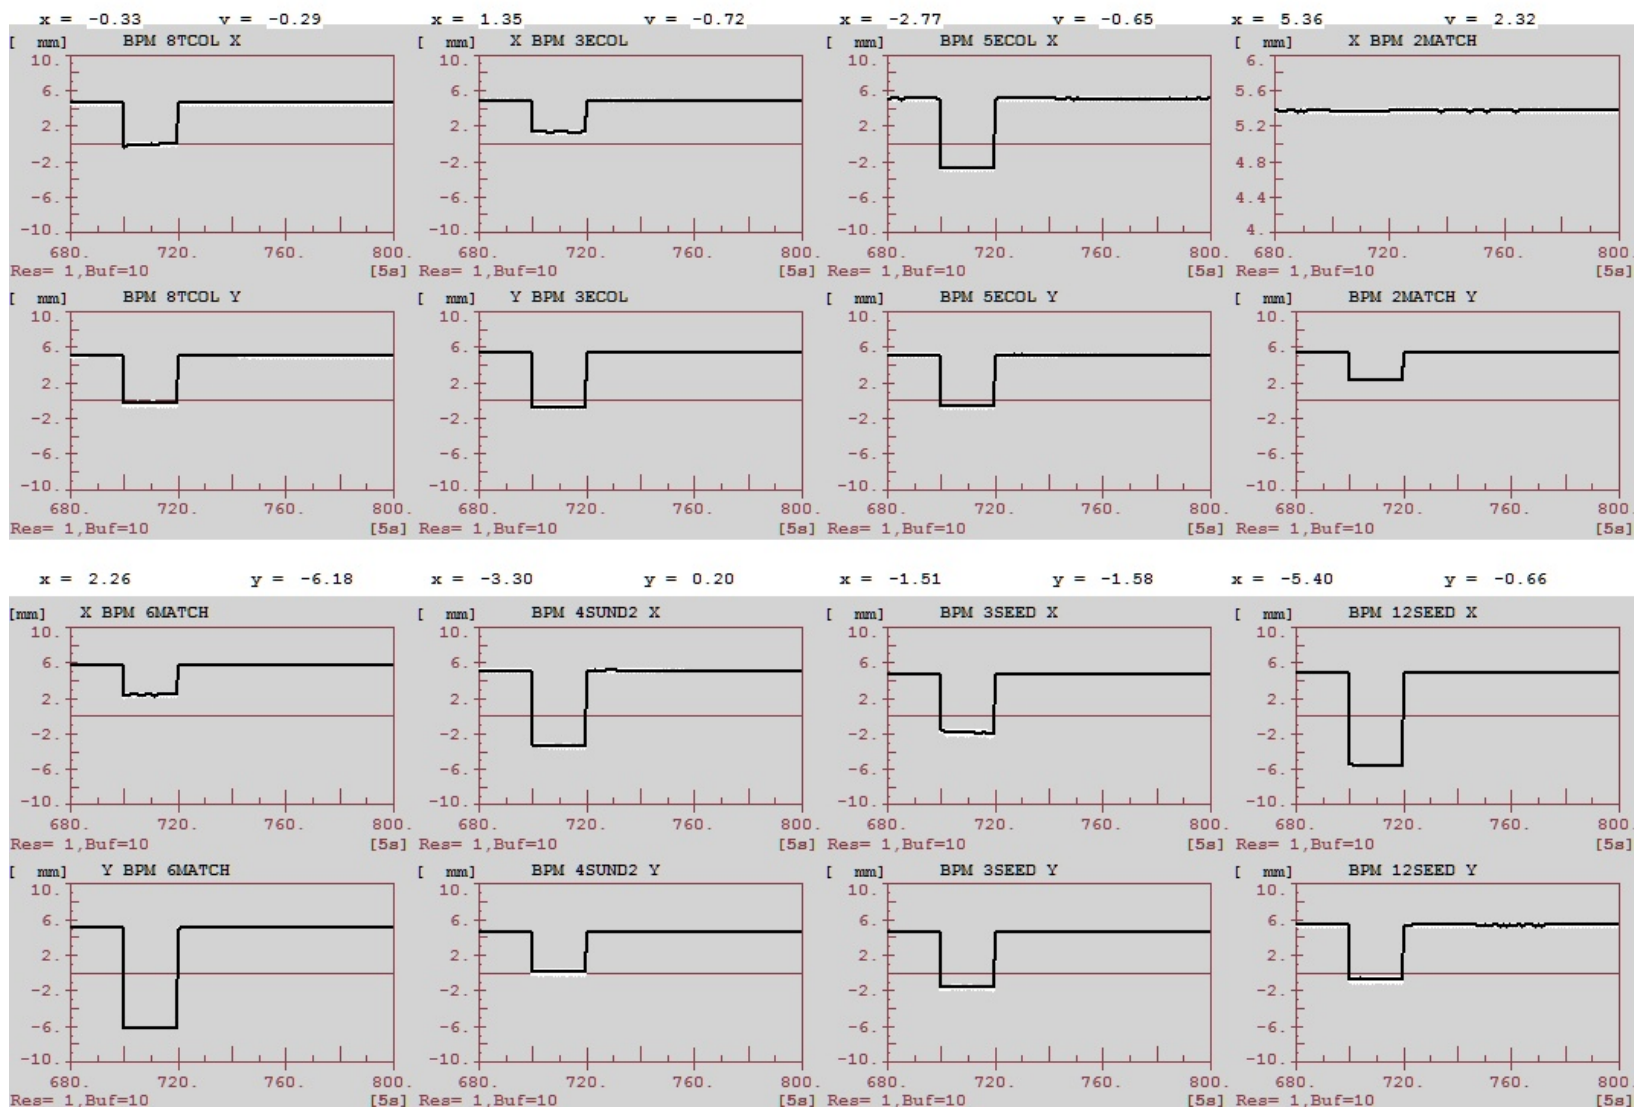
BPMs: Undulator Seed

- bad resolution at buttons, critical mostly in undulator
- no reliable signal at 12SEED and 20SEED
- bad or no signal at other individual BPMs
- instable trigger delay – critical for button BPMs

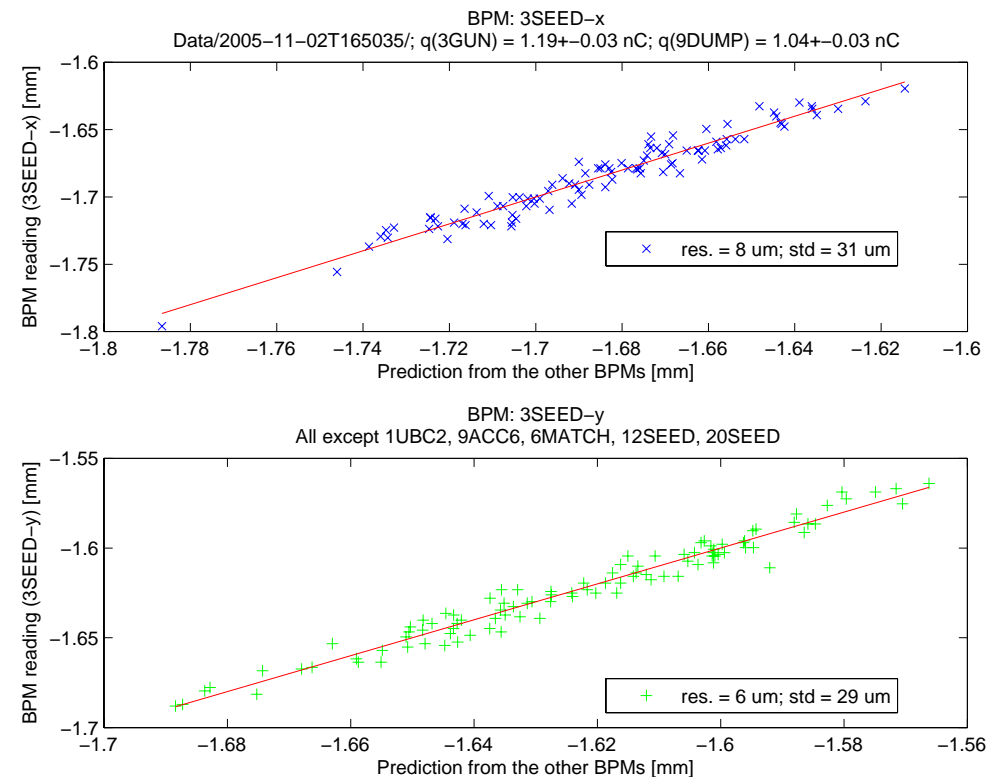
stripline (34mm)

- Measured by correlation of BPM signals
 - this represents only the electronics noise
 - the dependence on position, charge etc. is removed

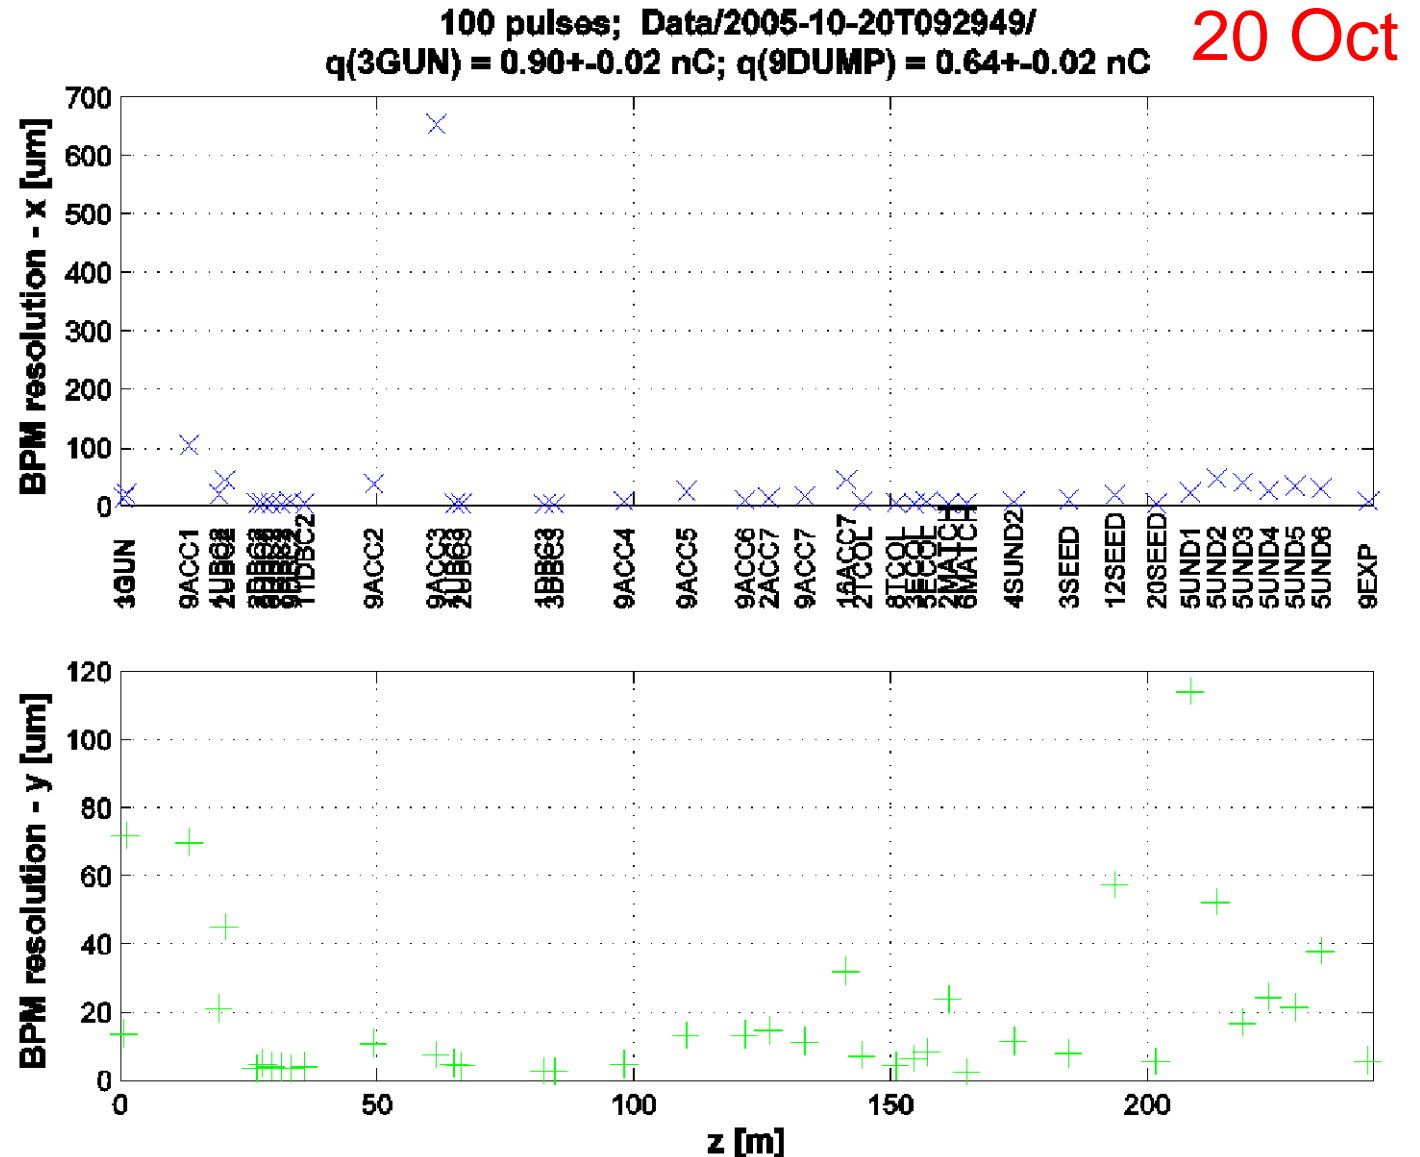
BPM resolution (2)

- Oct. 20
 - just after machine study weeks
- Note: UND BPMs **not calibrated!** – precise numbers will be available after calibration

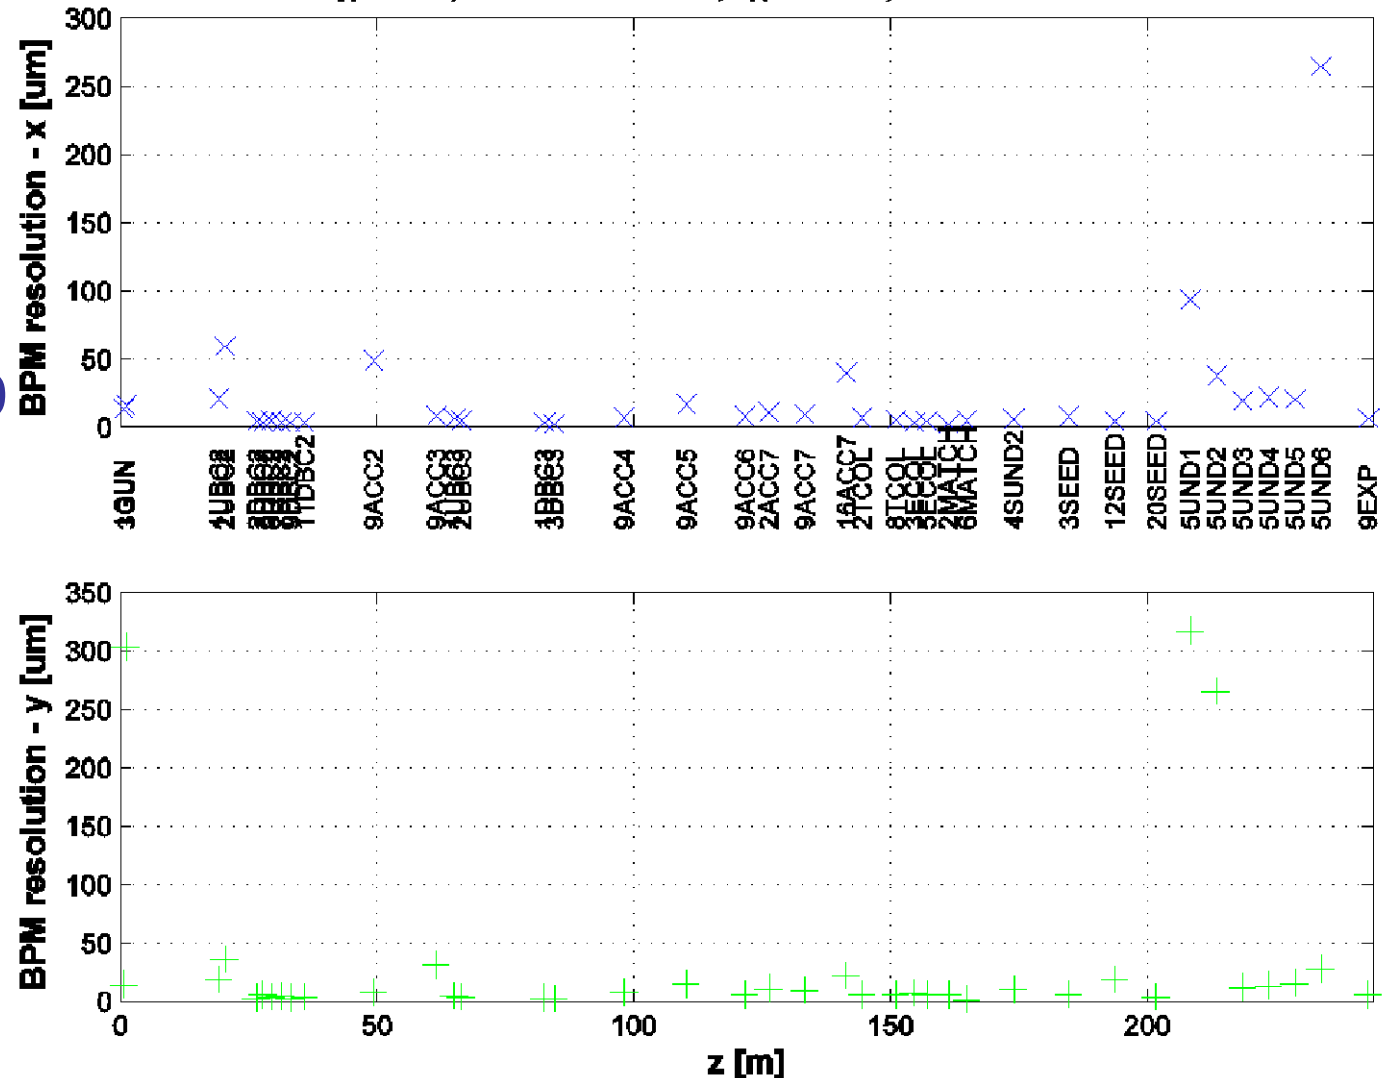
2 Nov

- Nov. 2 (now)
- Note: UND BPMs **not calibrated!**
- a few UND BPMs now show bad resolution, as compared to Oct. 20
 - need checkup (suspect trigger)

100 pulses; Data/2005-11-02T165035/
 $q(3GUN) = 1.19 \pm 0.03 \text{ nC}$; $q(9DUMP) = 1.04 \pm 0.03 \text{ nC}$

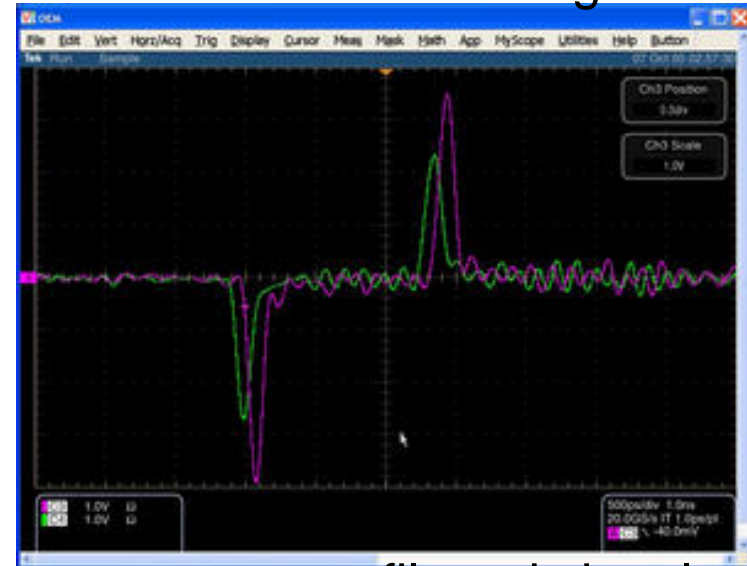
raw signals

- Signals from up and down pickups from 12SEED

- 0.9 nC
- scope mounted in tunnel
- similar to signals from 2MATCH! \Rightarrow no problem with pickup itself

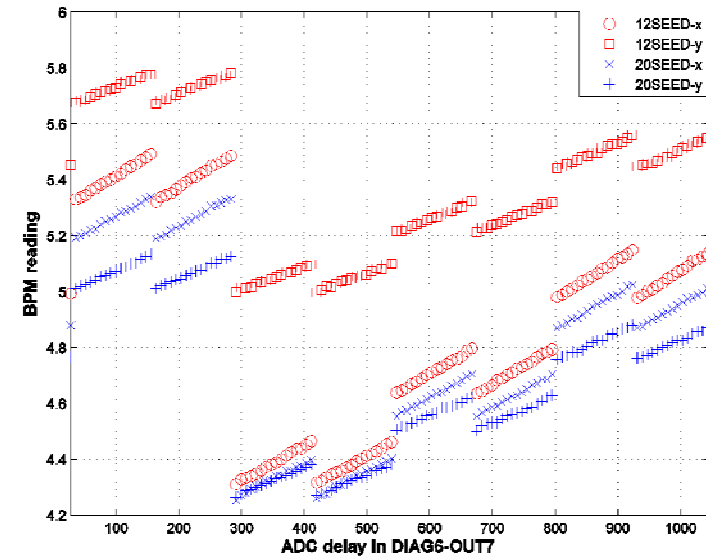
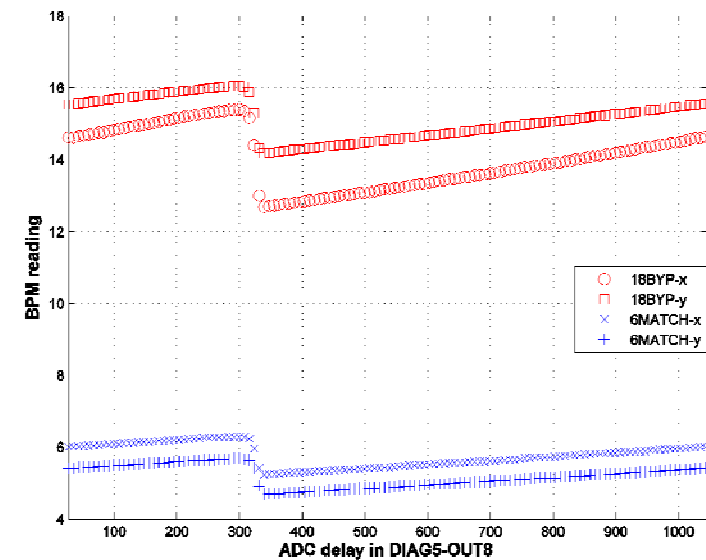
- looked different from other BPMs
- MVP changed delay unit =>
=> solved problem!

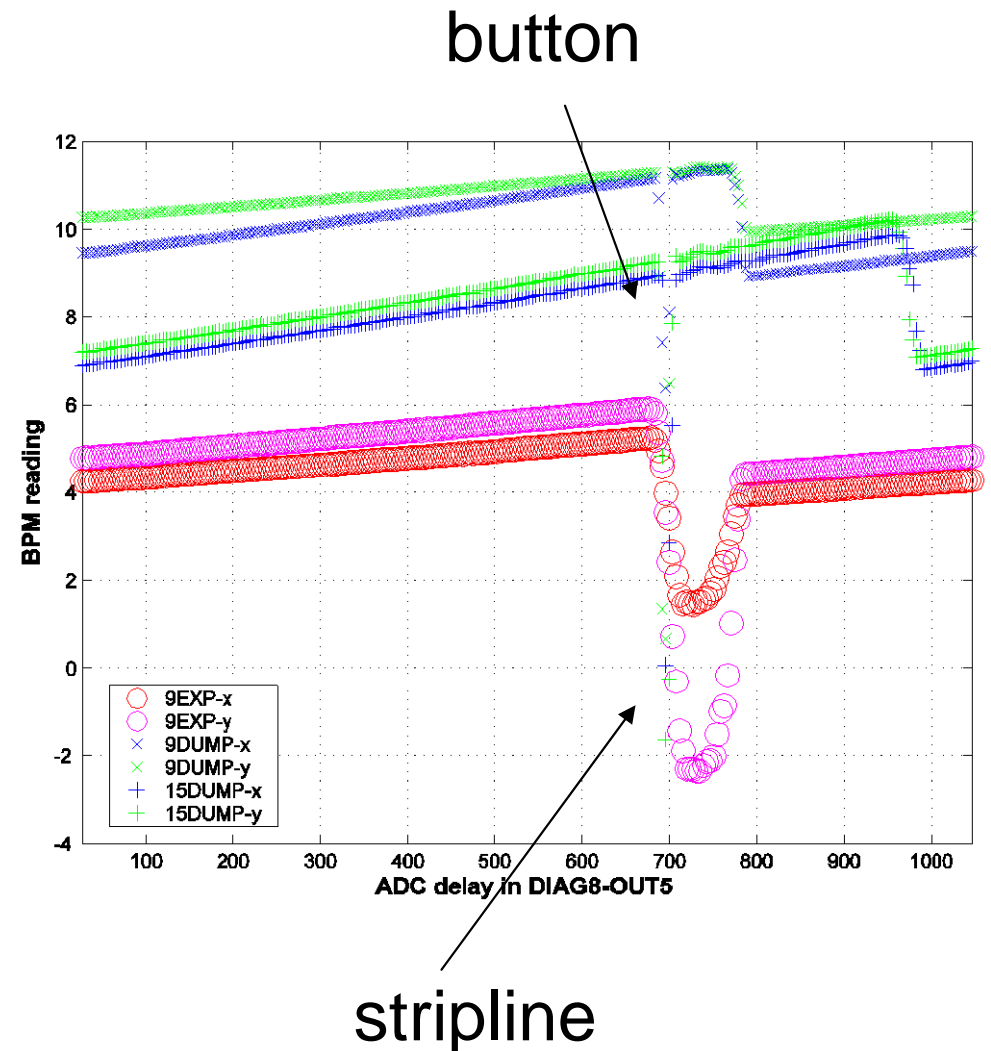
- Re-checked electronics settings, particularly delay
 - rough timing in DOOCS, finer in the electronics
 - very critical for button BPMs
 - checked for
 - all button BPMs in diagnostics stations and UBC2
 - after installation of additional amplifier
 - at other problematic BPMs
 - we systematically had to change the trigger delay by 4-8ns! (in DOOCS) – similar to toroids
