Report on the FEL optics activities

Damage investigations of FEL relevant optics

Hubertus Wabnitz and Kai Tiedtke

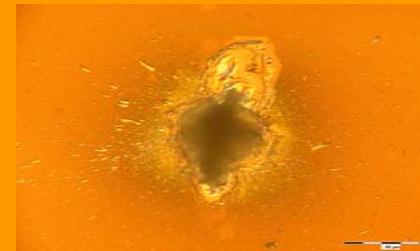
46nm amorphous C
on Silicon
at $\sim 10^{12} \text{ W/cm}^2$

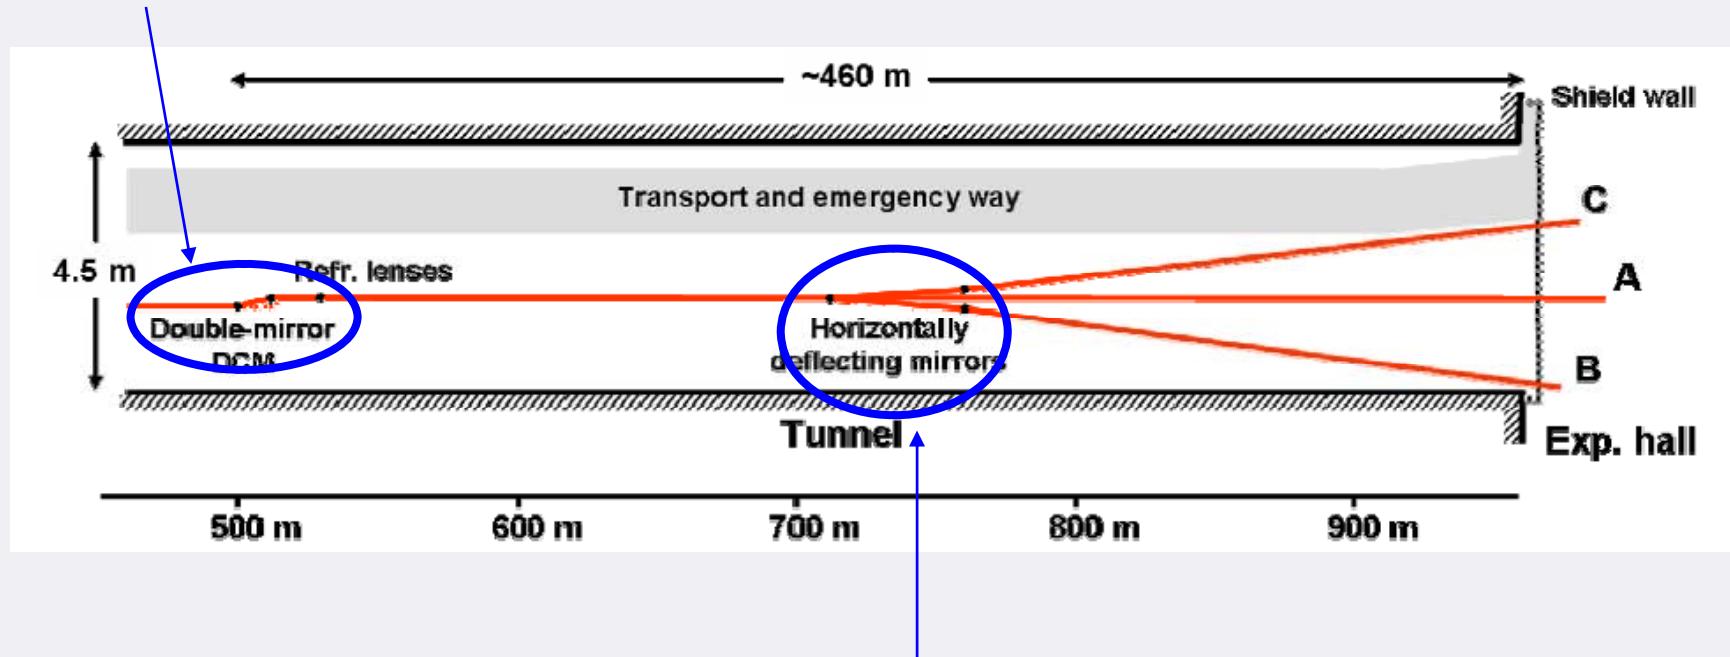
Why do we need mirrors?

beam off-set hinders Bremstrahlung etc. to enter experimental area

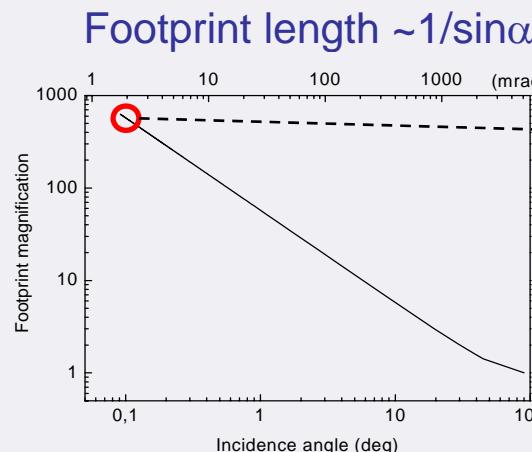
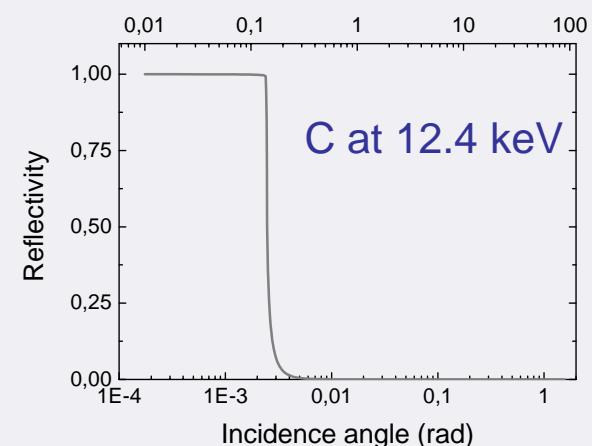
Gracing incidence angles
→ stretched footprint

at 2 mrad
elongation of ~500
→ footprint's length
~0.7m (6σ at 12.4 keV)

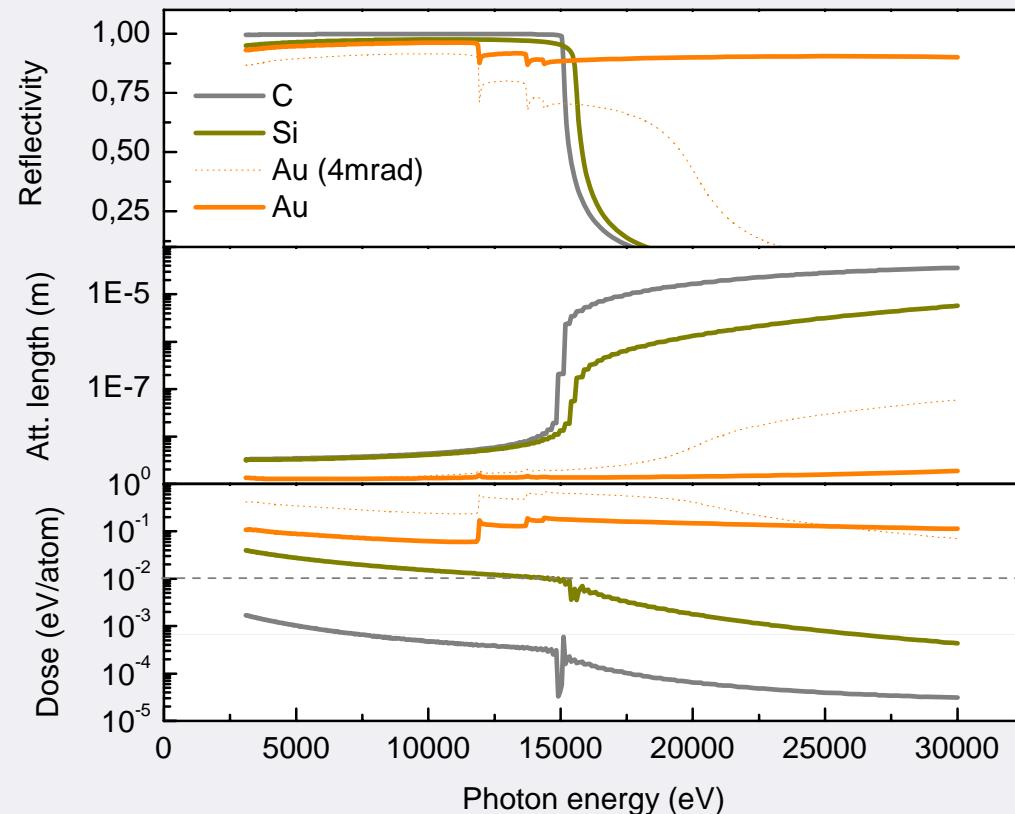
SASE 1 and SASE 2 Double-mirror

$\alpha=2$ mrad

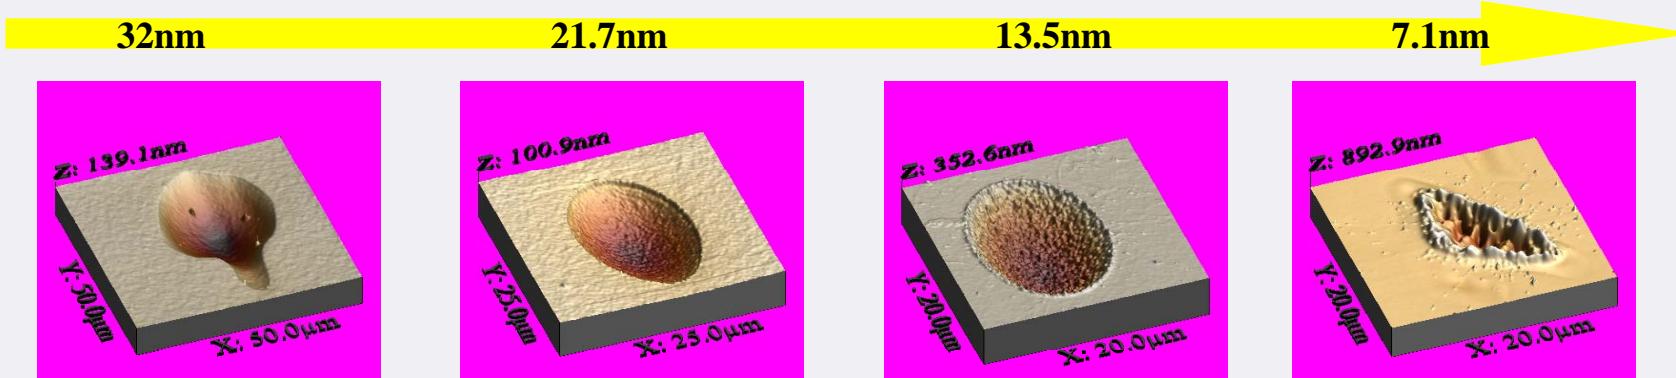
AFM pictures of PMMA for various wavelengths

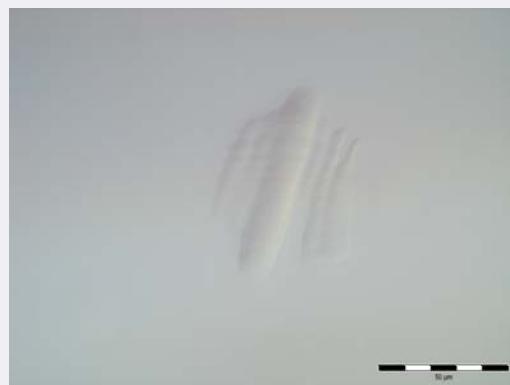
Focal imprint in PMMA:
1st shift at 13.5nm
– misaligned beamline -

| 1st shift : 8h @7nm | → found unexpected imprints |
| 2nd shift: 12h @13.5nm | → beam characterisation, verified misalignment of beamline |

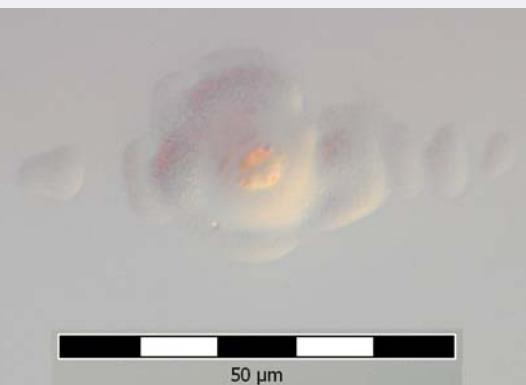
Focal imprint in PMMA:
3rd shift at 13.5nm
improved alignment

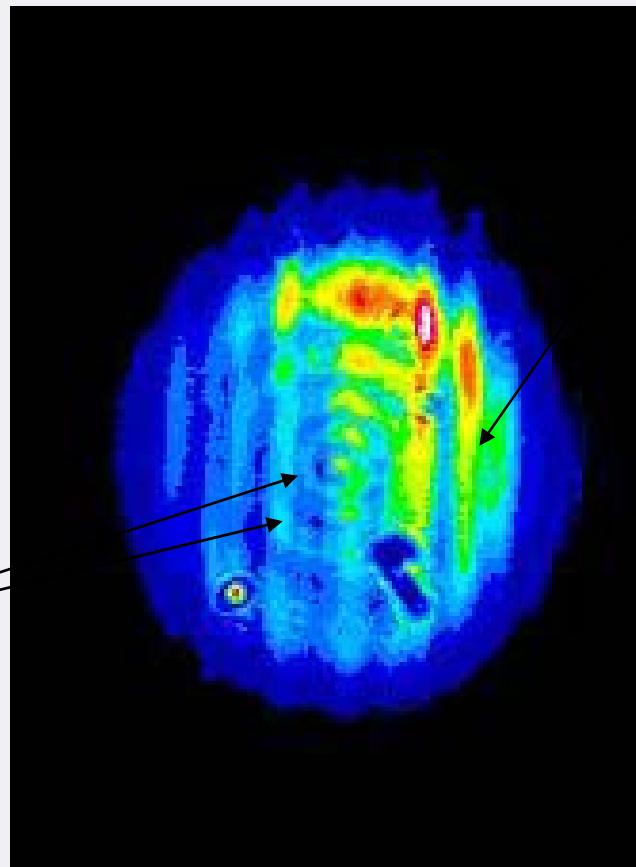
Image of photon beam

$\lambda=13.5\text{nm}$, 3mm-aperture

beam attenuated
with a $5\mu\text{m}$ thick Silicon foil
to protect CCD chip

concentric feature expected
(diffraction at beam aperture)

vertical feature is a bug
(diffraction at edge, somewhere)

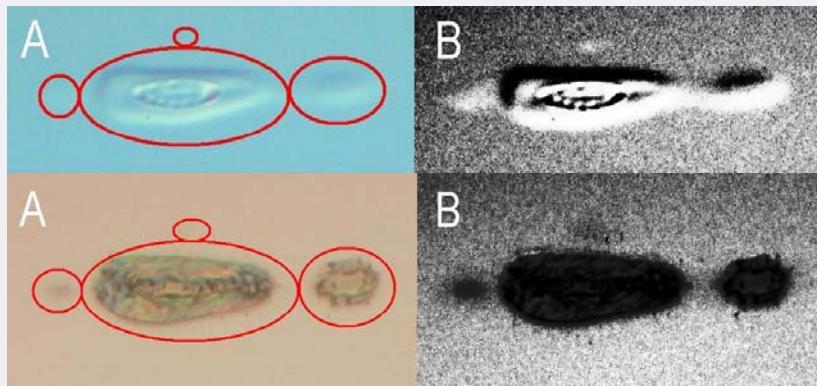
Multilayer samples

Got reasonable results (dam. thresholds...)
with „4 spot“ assumption
→ fulfilled only for stable beam conditions!!

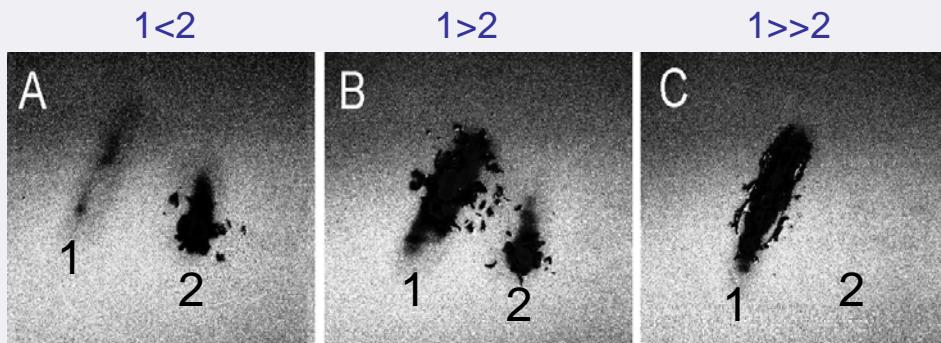
„Flipping intensities“
→ unstable beam conditions
